American Rivers
Rivers Connect Us

Restoration of Priority Meadows in the Walker Watershed

FINAL MONITORING REPORT

January 2022

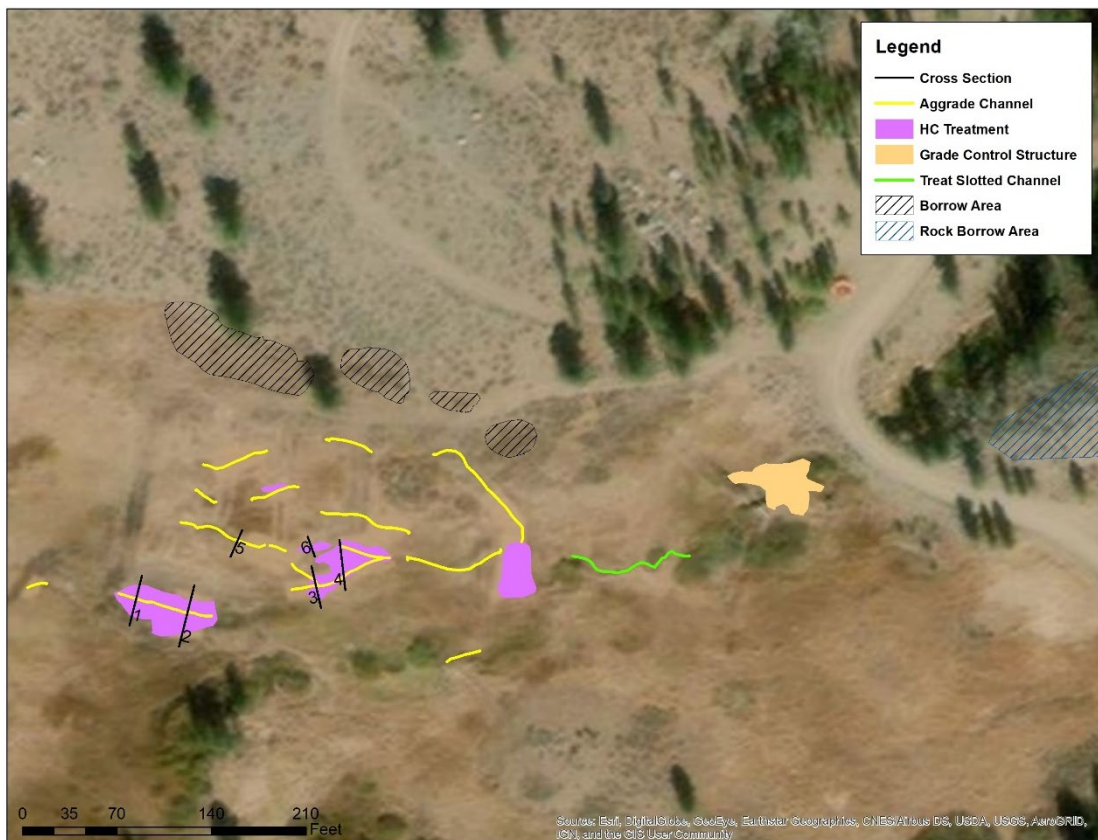
Figure 8. As-built designs for Cloudburst Meadow. Shows the location of cross-section surveys and the extent of project features developed using GPS.

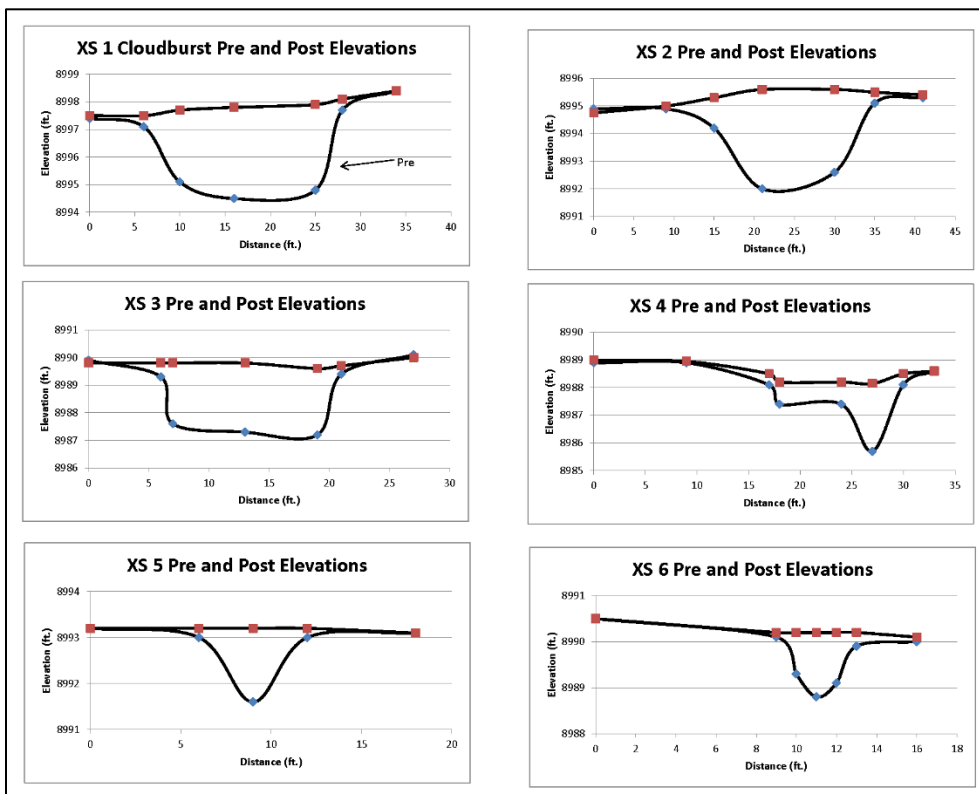
Figure 9. Comparison of cross section surveys pre- (2016) and post- (October 2018) construction for Cloudburst.

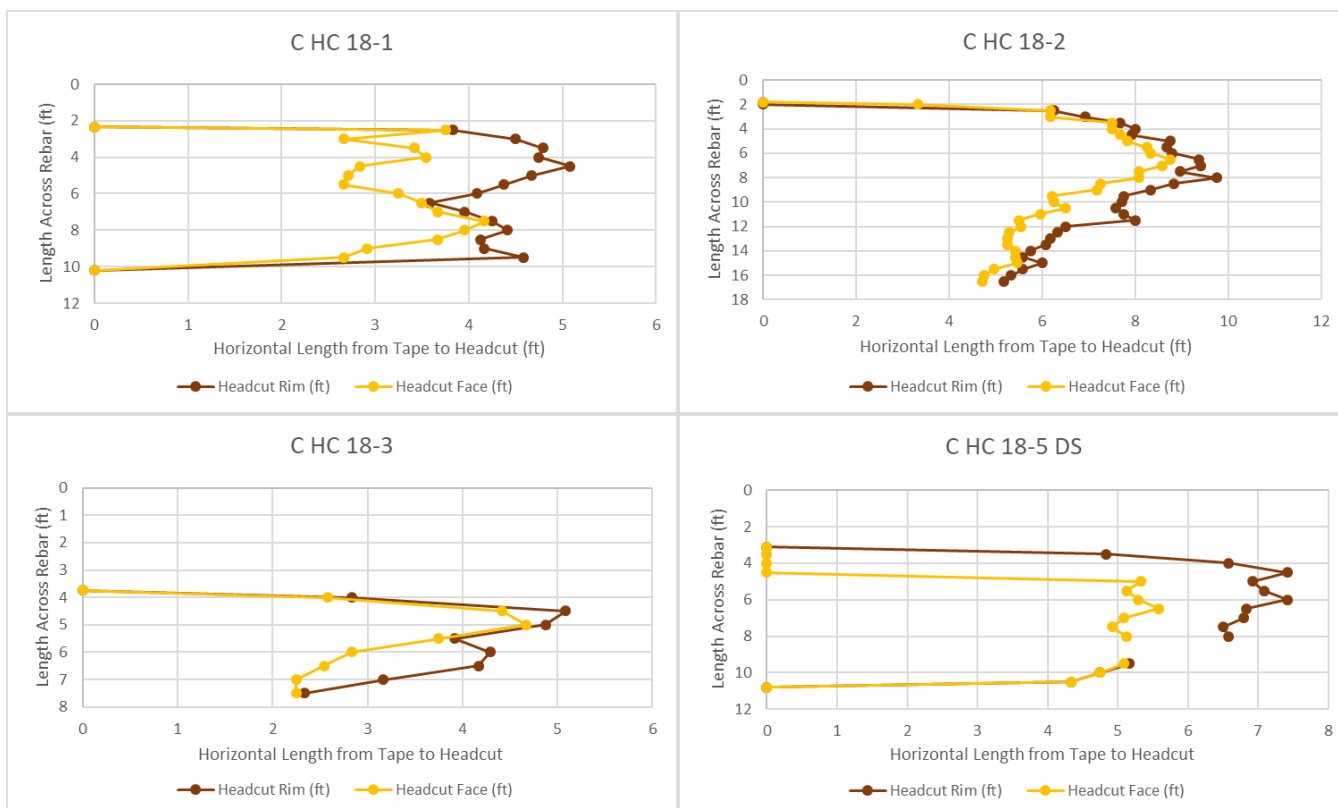
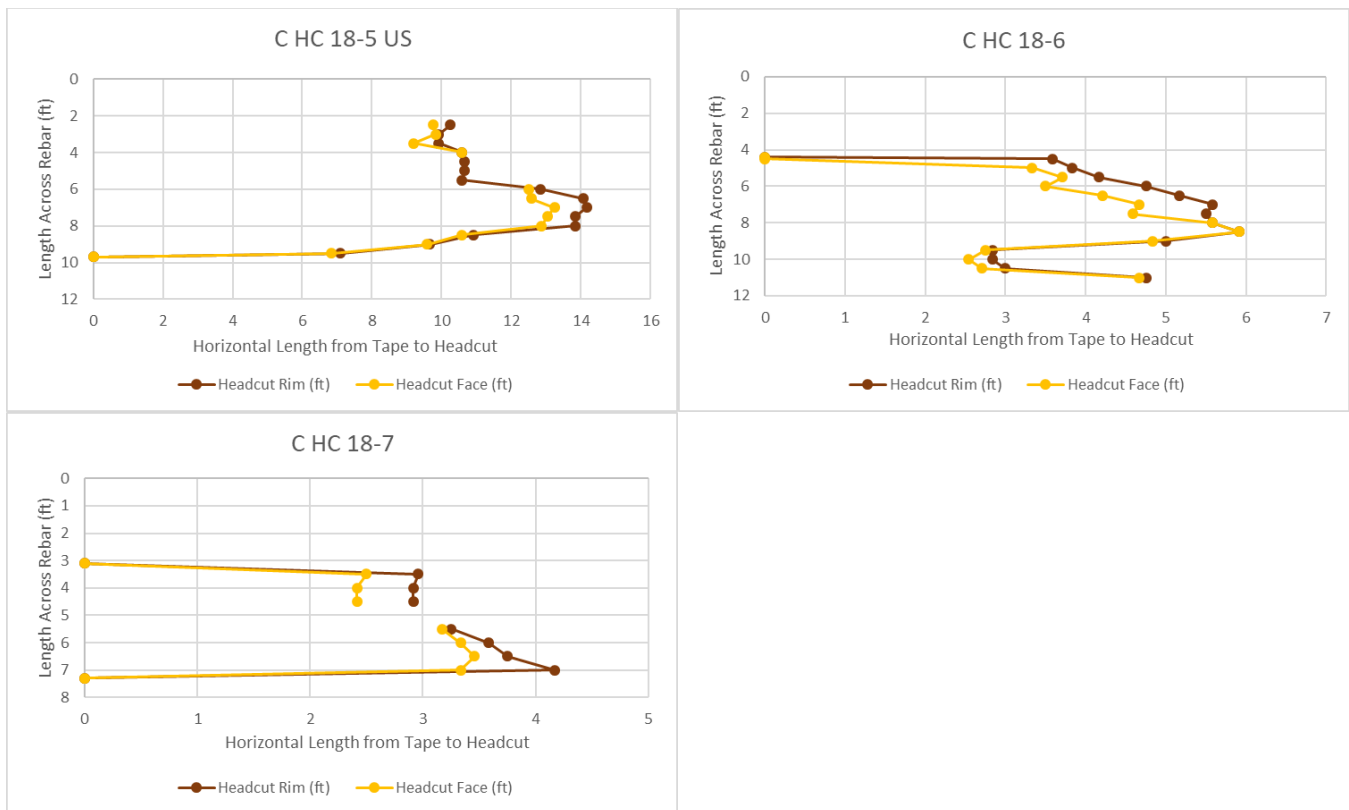
Figure 14. The results of headcut monitoring in Cloudburst Meadow showing the lengths from the measuring tape to the headcut rim (farthest edge of erosion) and headcut face (highest point on the vertical face above the drop pool). C HC 18-5 had two sub-headcuts, one upstream (US) and one downstream (DS). We took separate measurements of each feature from the same tape position. The gaps in data in C HC 18-5 DS and C HC 18-7 are due to the headcut transitioning into a channel above the headcut. At C HC 18-5 the headcut face was not well defined between 4.5 and 5.5 and no measurements were taken.

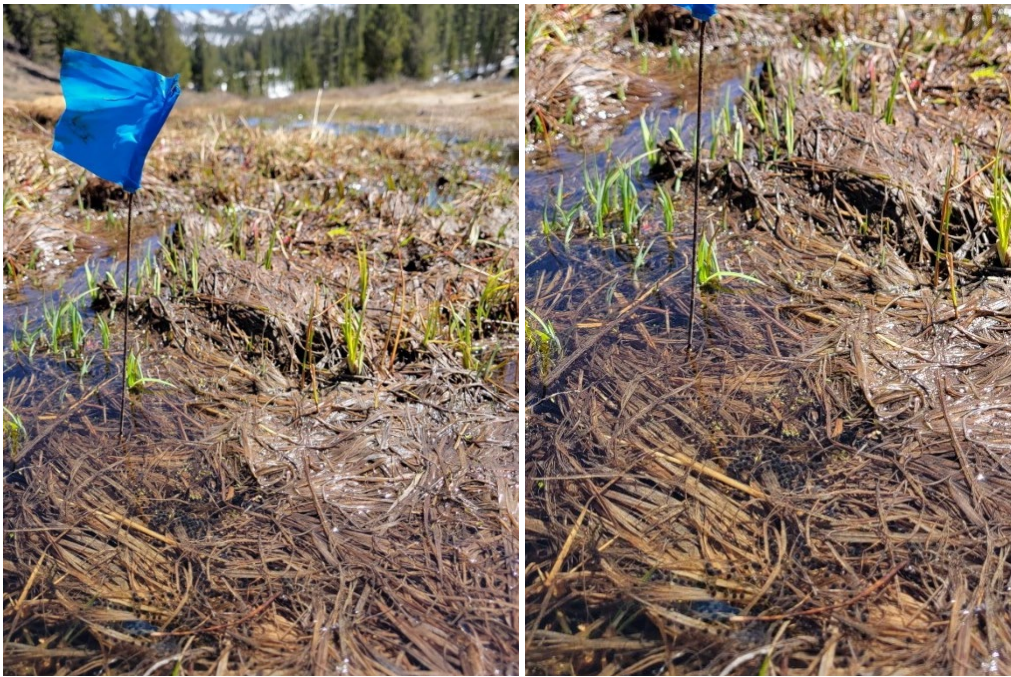
Figure 22. Photo of egg masses in the restored area in Upper Sardine Meadow in May 2021. Zoomed out (left) and zoomed in (right). See dark spots at the base of the flag.

There are too many unknowns to attribute the marked increase in number of individuals in Upper Sardine to restoration, which only affected a portion of the breeding area, although it may play a role. But a highlight is that in 2021, the HTNF observed egg masses (indicating breeding) in the vicinity of the restoration project for the first time (Figure 22). Note the increase from three to four distinct breeding locations for Upper Sardine from 2020 to 2021 in Table 9. Although the surface water breeding habitat monitoring was not conducted in Upper Sardine, the HTNF noted distinct breeding areas during CMR surveys. Also, in general the HTNF observed breeding toads utilizing the restored area in Upper Sardine (Figure 23).

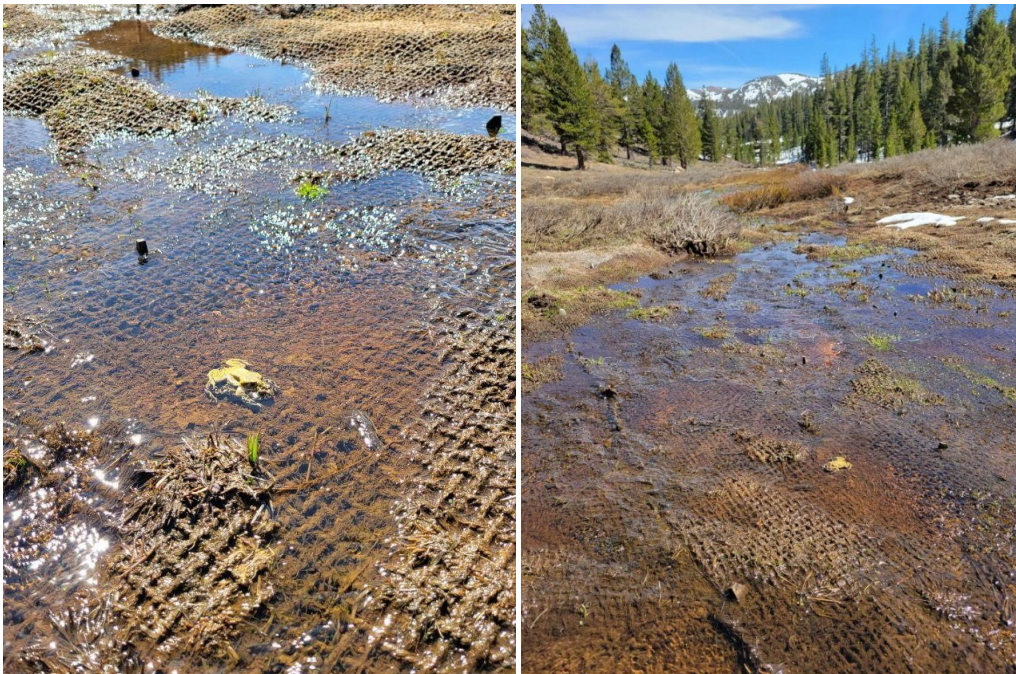
Figure 23. Photo of Yosemite toads in the restored area of Upper Sardine Meadow during breeding season 2021. A breeding pair is shown in left photo.

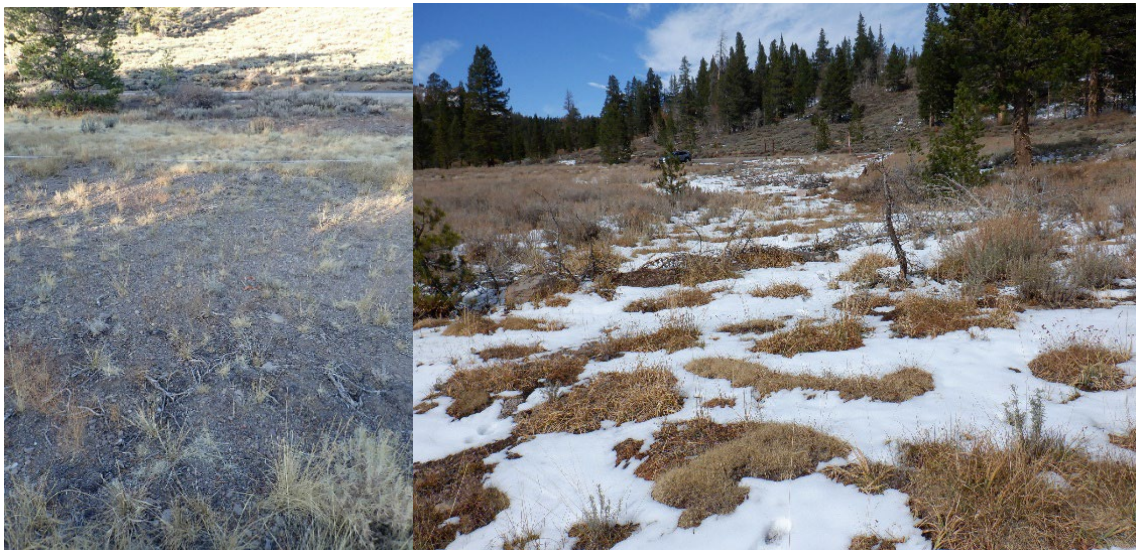
Overall, vegetation is re-establishing rapidly at Lower Sardine, except for the most upstream portion of the project, which has not yet re-established to 70 percent of natural vegetation (VT-1). This portion of the project was naturally drier and received more compaction during construction, as equipment accessed the site. We will continue to monitor this area and apply sod plugs or other means to encourage vegetation growth if conditions do not improve. The middle and lower portion of the swale are having more vegetative recruitment, as indicated

Figure 25. VT 1 in 2020 (left); Looking upslope toward VT-2 in 2021 (right).

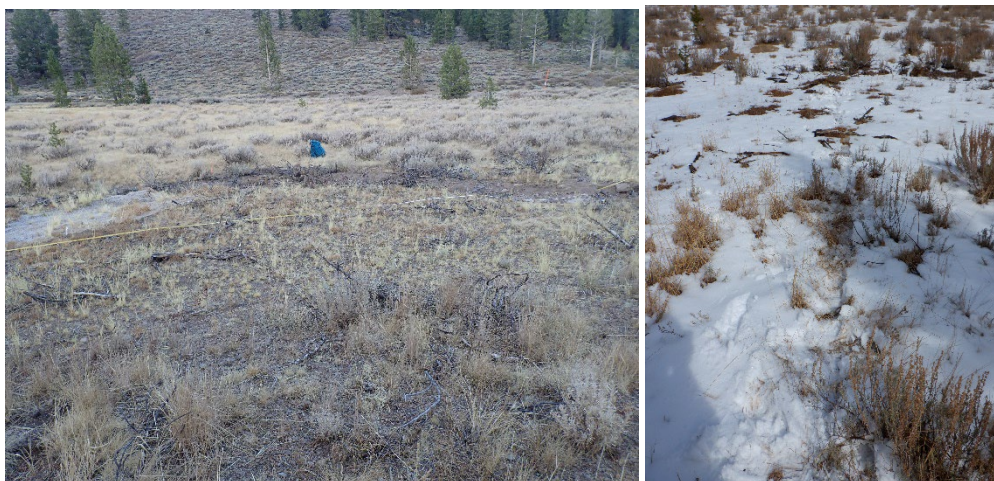
Figure 26. VT-3 in 2020 (left) and 2021 (right).

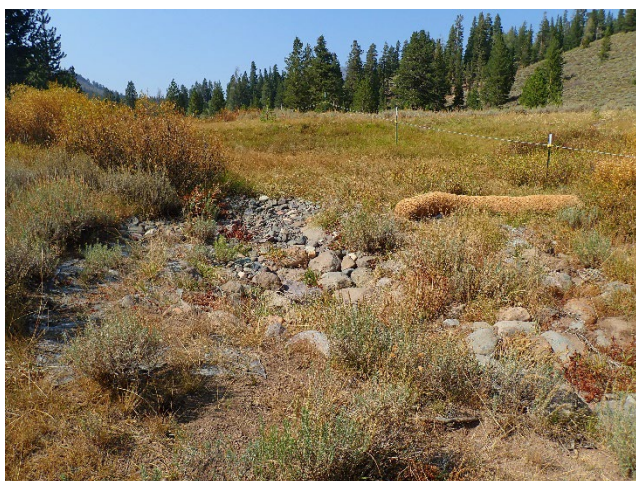
by VT-2 and VT-3. The grade control structure is beginning to become vegetated, but is not yet at 70% cover since additional rock was added in 2020.

Figure 27. Photo of grade control structure from September 2021.

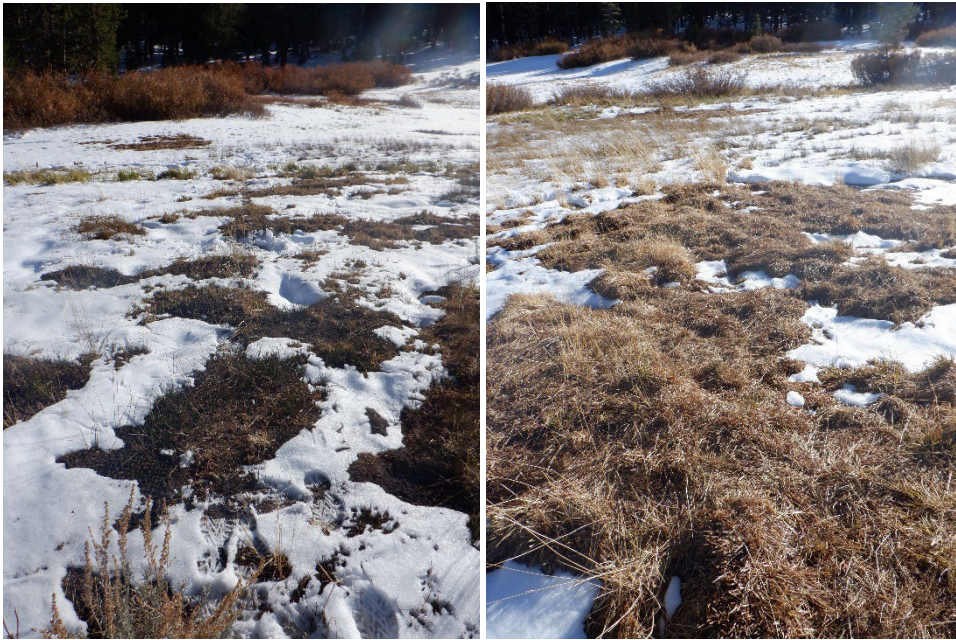
Vegetation is re-establishing rapidly on areas disturbed by 2018 construction activities in Cloudburst Meadow. Most of the headcut repair areas are exceeding 70% cover, as evidenced by VT-1 and VT-2. Vegetation is beginning to re-establish on areas disturbed by construction of the grade control structure in 2019, but is not yet 70% of natural as indicated by VT-3. Additionally, a portion of the structure was re-disturbed in 2020. We will continue to monitor this area and adaptively manage, if needed.

Figure 29. VT-1 (left) and VT-2 (right) in 2021.

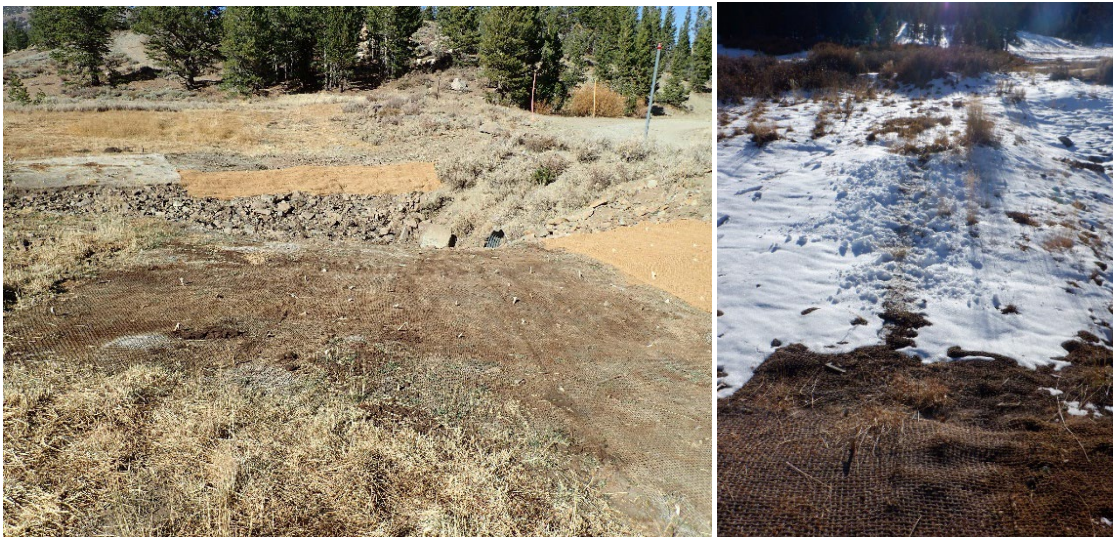
Figure 30. Looking from VT-3 toward grade control in 2020 (left), and photo of VT-3 from 2021 (right).

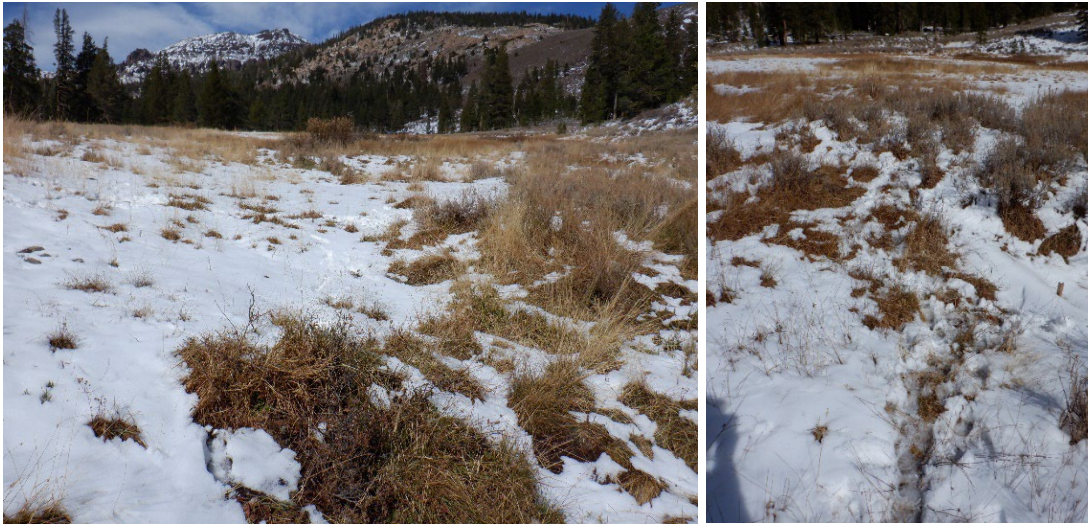
Vegetation is re-establishing rapidly on areas disturbed by 2019 construction activities in Upper Sardine Meadow. The headcut repair areas have re-established greater than 70% cover, as indicated by VT 1 and VT 2. Although the grade control is comprised of mostly rock, it has shown some regrowth, although not at 70% cover. Additional wattles were installed for erosion control in 2020. The borrow area has also had slower regrowth but the erosion fabric and wattles have been successful at reducing erosion and cover is approaching 70% as indicated by VT-3. We will continue to monitor sites and adaptively manage to encourage cover if needed.

Figure 32. Looking up at VT-1 in 2021 (left). VT-2 in 2021 (right).

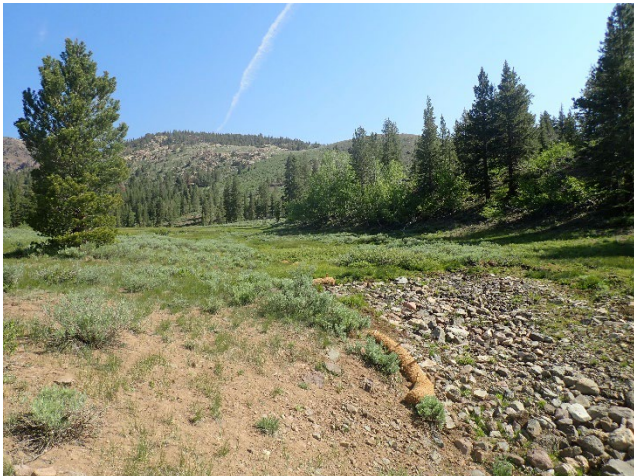
Figure 33. Grade control in 2021.

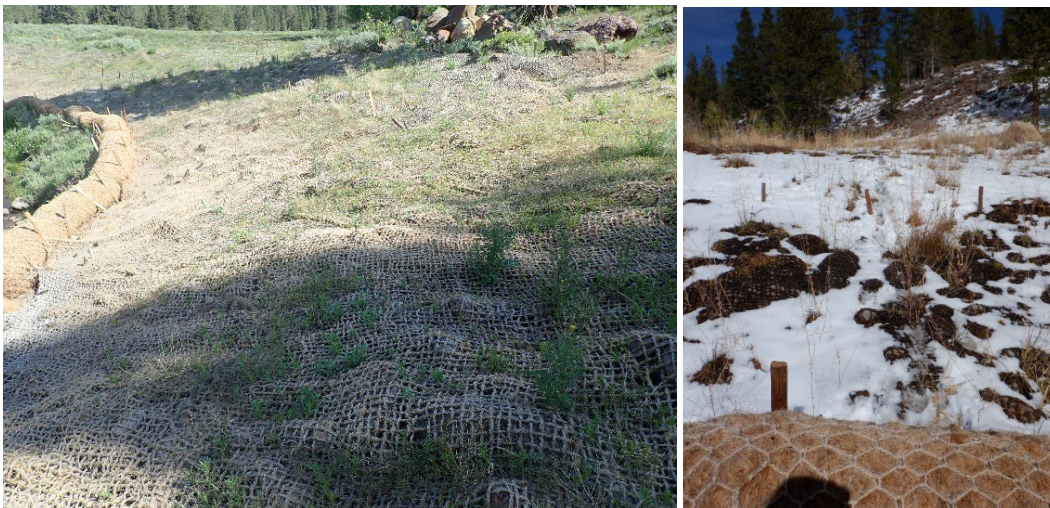
Figure 34. Borrow area in 2021 (left) and VT-3 in 2021 (right).

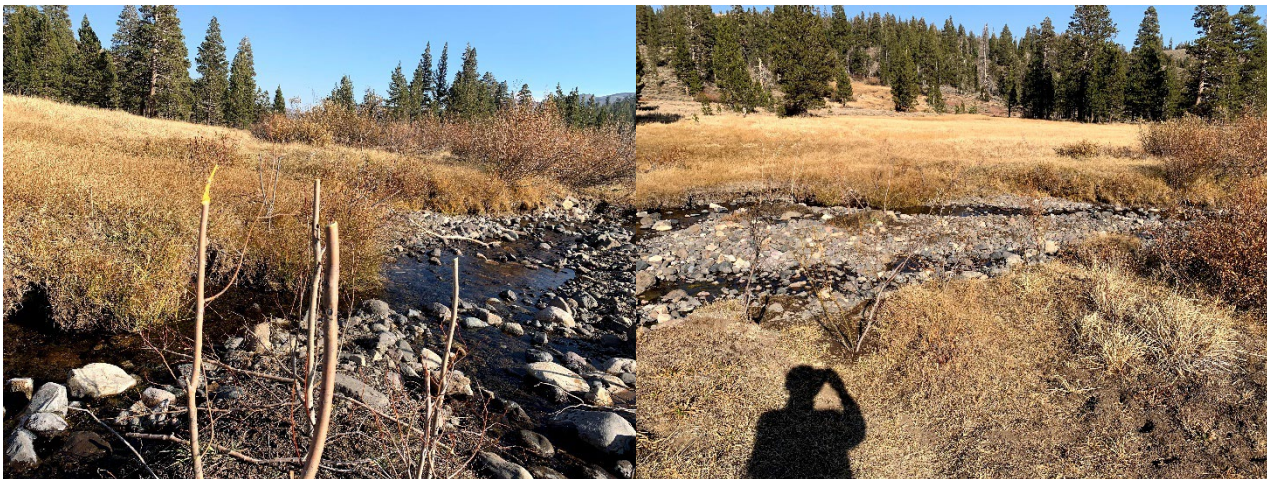
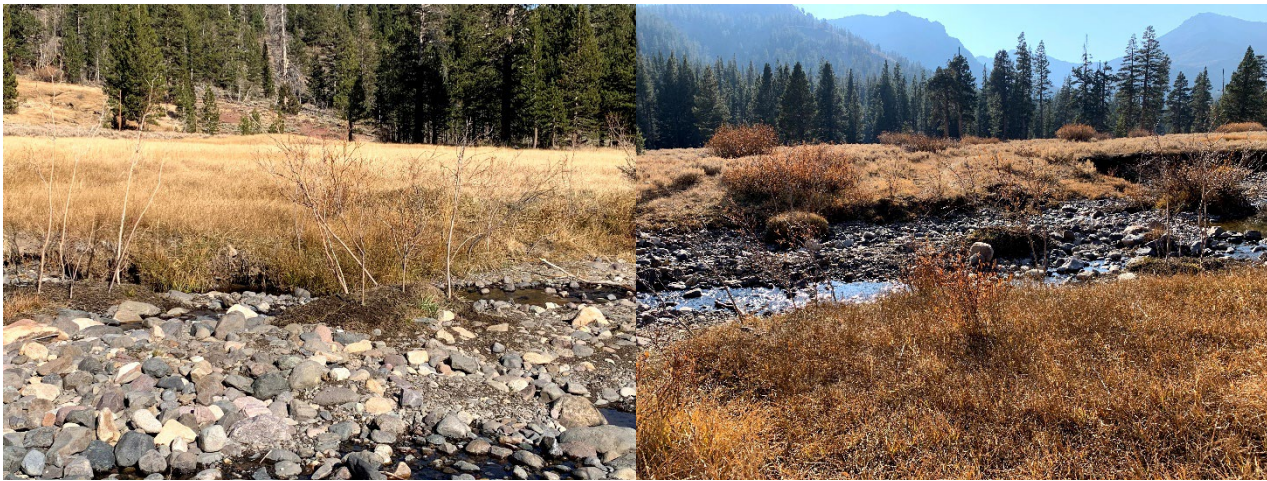
Figure 36. Photos of willow stake planting along Sardine Creek in Lower Sardine Meadow in 2020

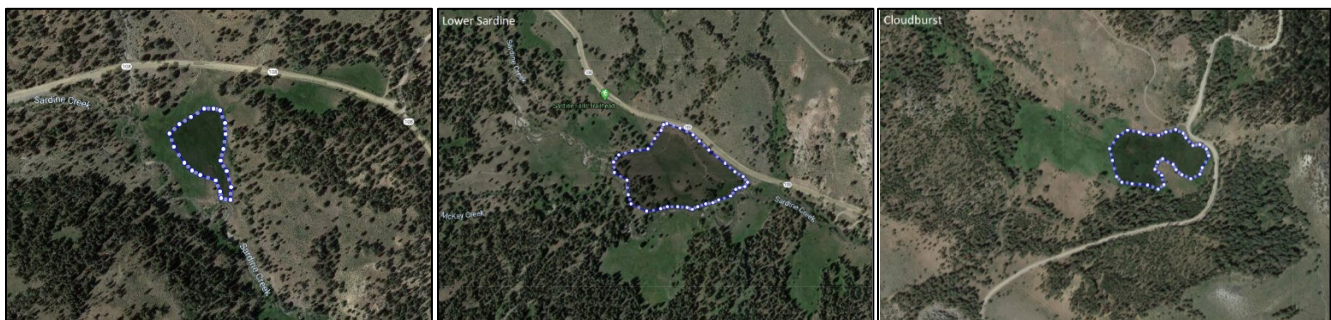
Figure 37. Polygons used for NDVI/NDWI calculations at Upper Sardine (left), Lower Sardine (middle) and Cloudburst (right).
